Manhole Inspection Summary

Manhole # S49E__010MH

Insp Date: **12/3/08 12:49 PM**

Location Address: **side 1 n milton st**

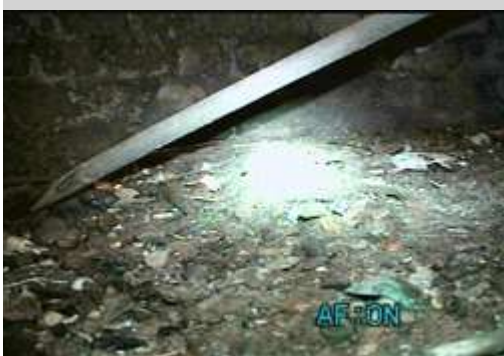
miscellaneous

debris

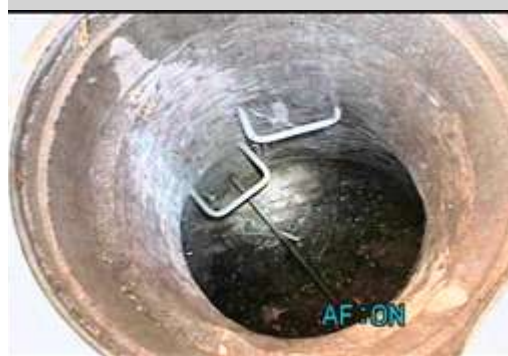
Defect 1

Steps Count: **2** Missing: **0** ☒ **Corroded**

corr steps

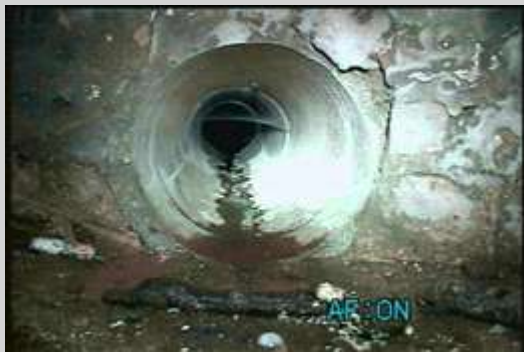
12 O'Clock Outflow

8 in. Circular Gravity Sewer
Pipe Out @ 12 O'Clock

Deposits: ☒ None ☐ Mud ☐ Sludge ☐ Debris ☐ Grease

Infiltration: **None** Pipe Seal Cond: **Unknown**
